Challenge

Issue

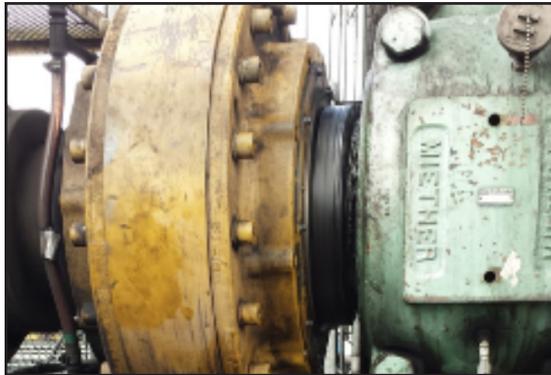
- A client experienced continuous oil leaks after startup on a conveyor gearbox.
- Contamination was entering the bearing housing, resulting in frequent seal changes and considerable downtime costs.
- The seals lasted only four weeks.

The plant's conveyor equipment leaked excessively.

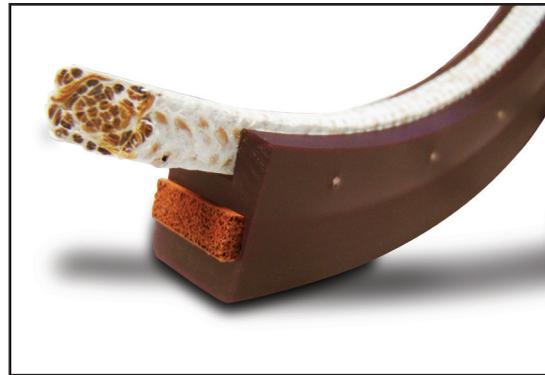
Chesterton Matrix Rotary Seal combines two materials for exceptional performance.

A Chesterton representative installed two **Chesterton Matrix Rotary Seals**:

- One faced the bearing to seal lubrication.
- The other faced the retainer ring to prevent outside contamination from entering the bearing housing.
- Both seals were installed rapidly without the need for disassembly of equipment, thereby minimizing downtime.

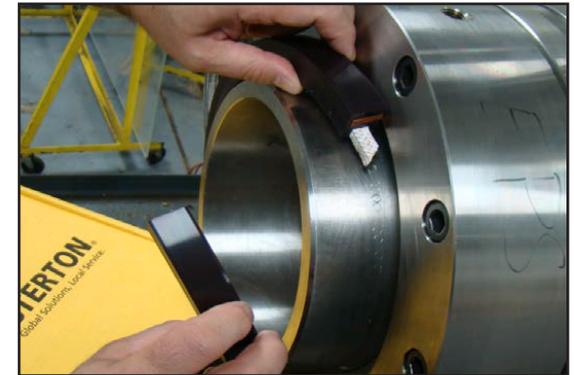
The **Matrix Seal** installation is very simple and fast.

- MTBR increased to 18 months, 12X the previous method with zero leakage!
- **Matrix Seals** offer an excellent solution for long-term bearing protection.
- With the split seal design, the **Matrix Seal** can be installed in minutes, delivering significant savings on critical downtime!
